Parks
Canada

EXCAVATIONS AT THE FORTRESS OF LOUISBOURG
OF THE DE PENSENS-DE LA VALLIERE STOREHOUSE
AND NEW ENGLAND CRAFTSMEN'S SHOP, LOT D,
BLOCK 16, AND OF THE LOPPINOT-DANGEAC HOUSE
AND PROPERTY, LOT C, BLOCK 16

by Pierre Beaudet

1977

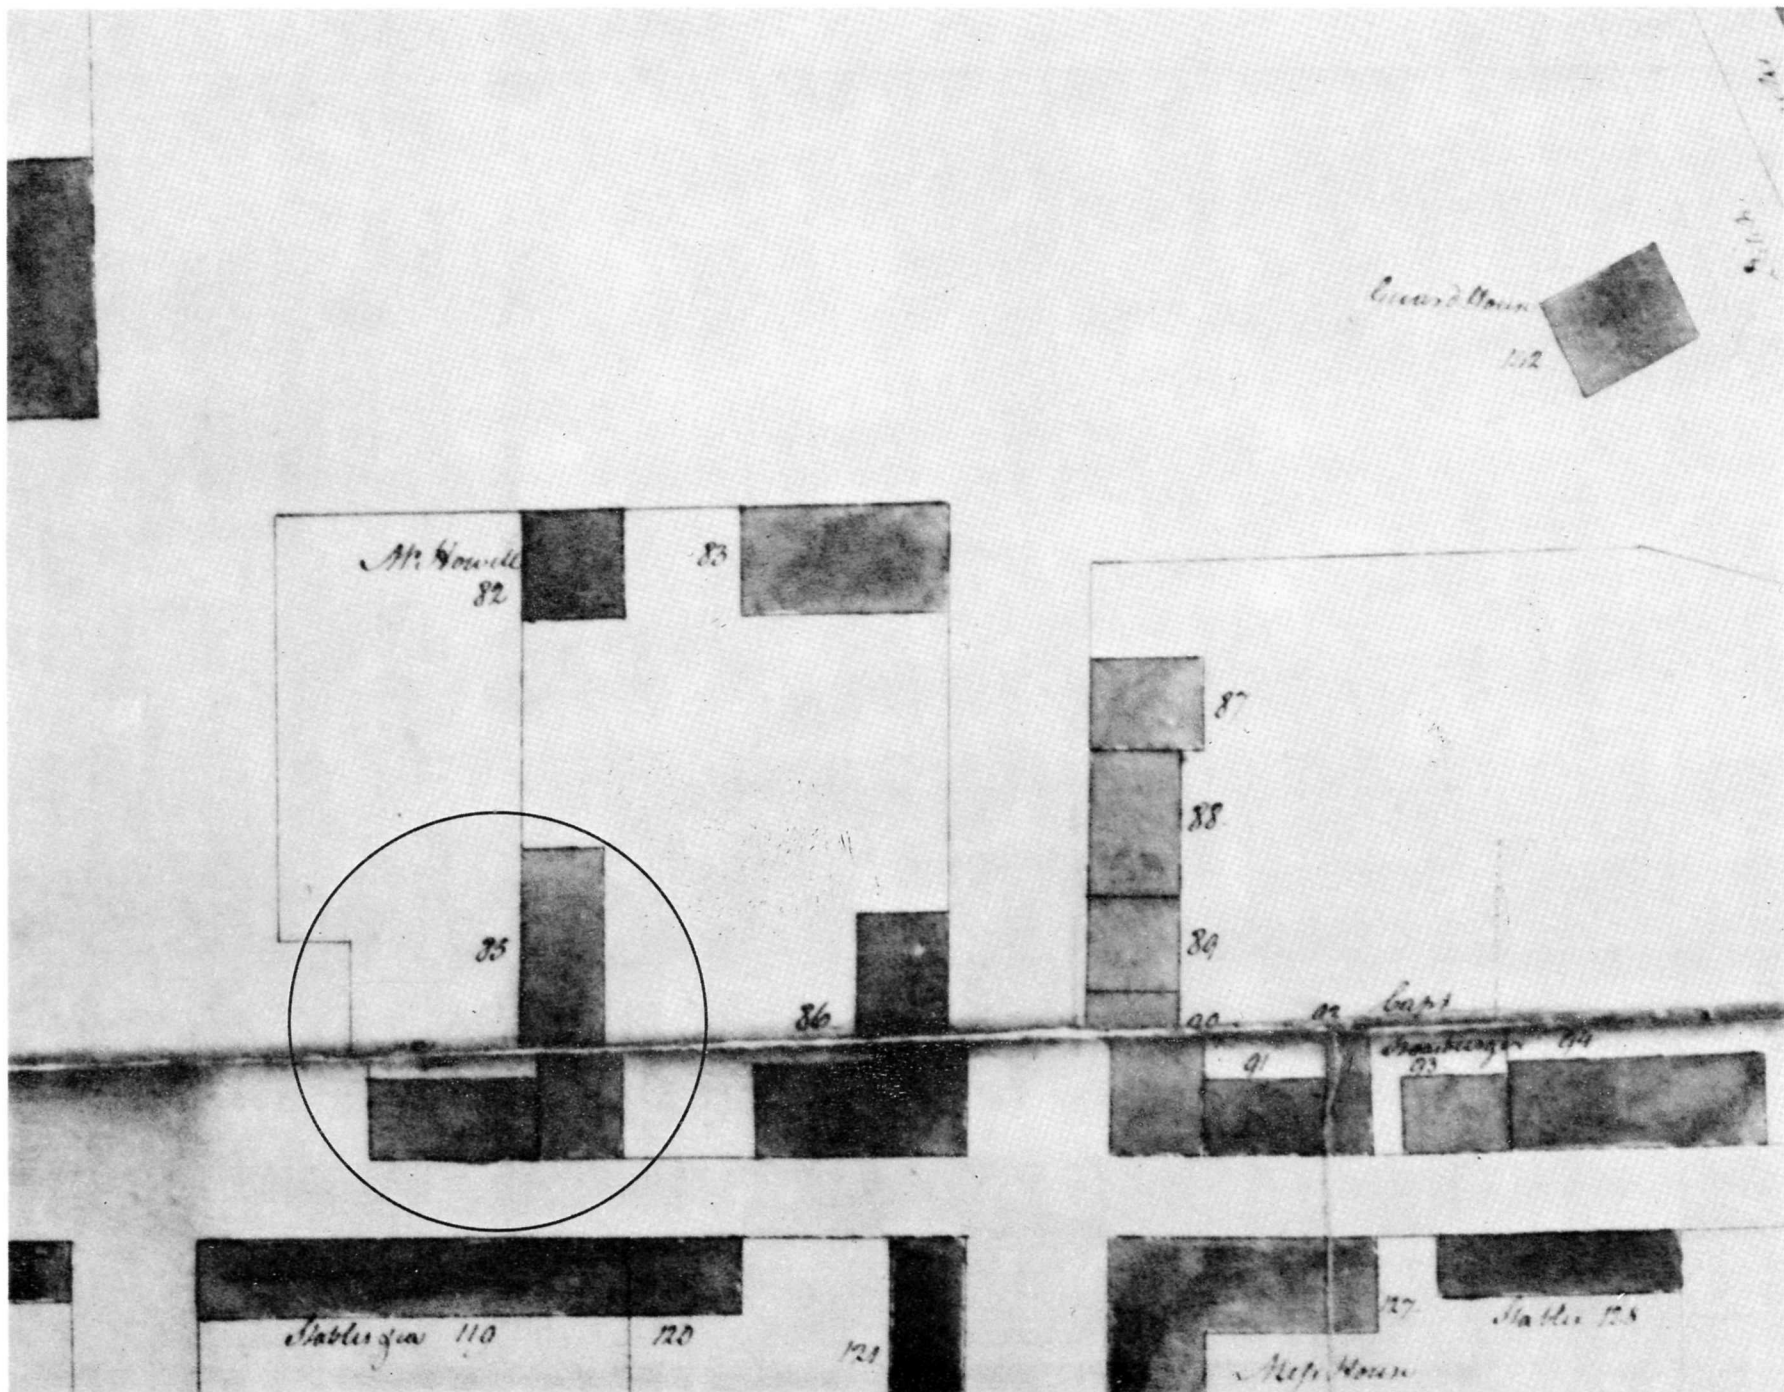
Figure 8: Topography and site plan of Block 16
and vicinity.

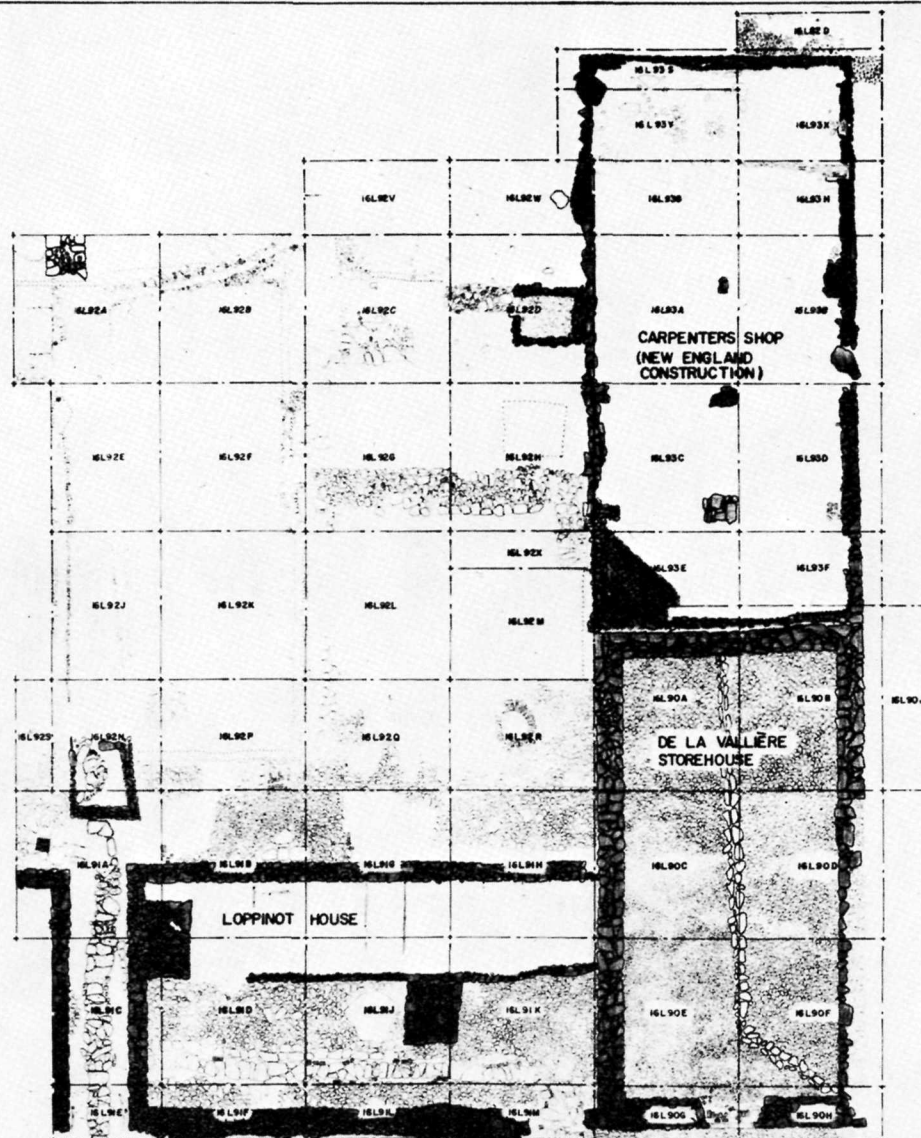
Figure 10: Plan of excavated features discussed
in this report.

The remains of a roughly rectangular structure were uncovered from the northwest corner of the excavation (Fig. 10,13,14). This area corresponded, historically, to the northeast corner of Lot D while the structural remains were found to be those of the de Pensens-de la Vallière storehouse (see historical introduction in this report). The exterior foundation remains of the storehouse were as follows:

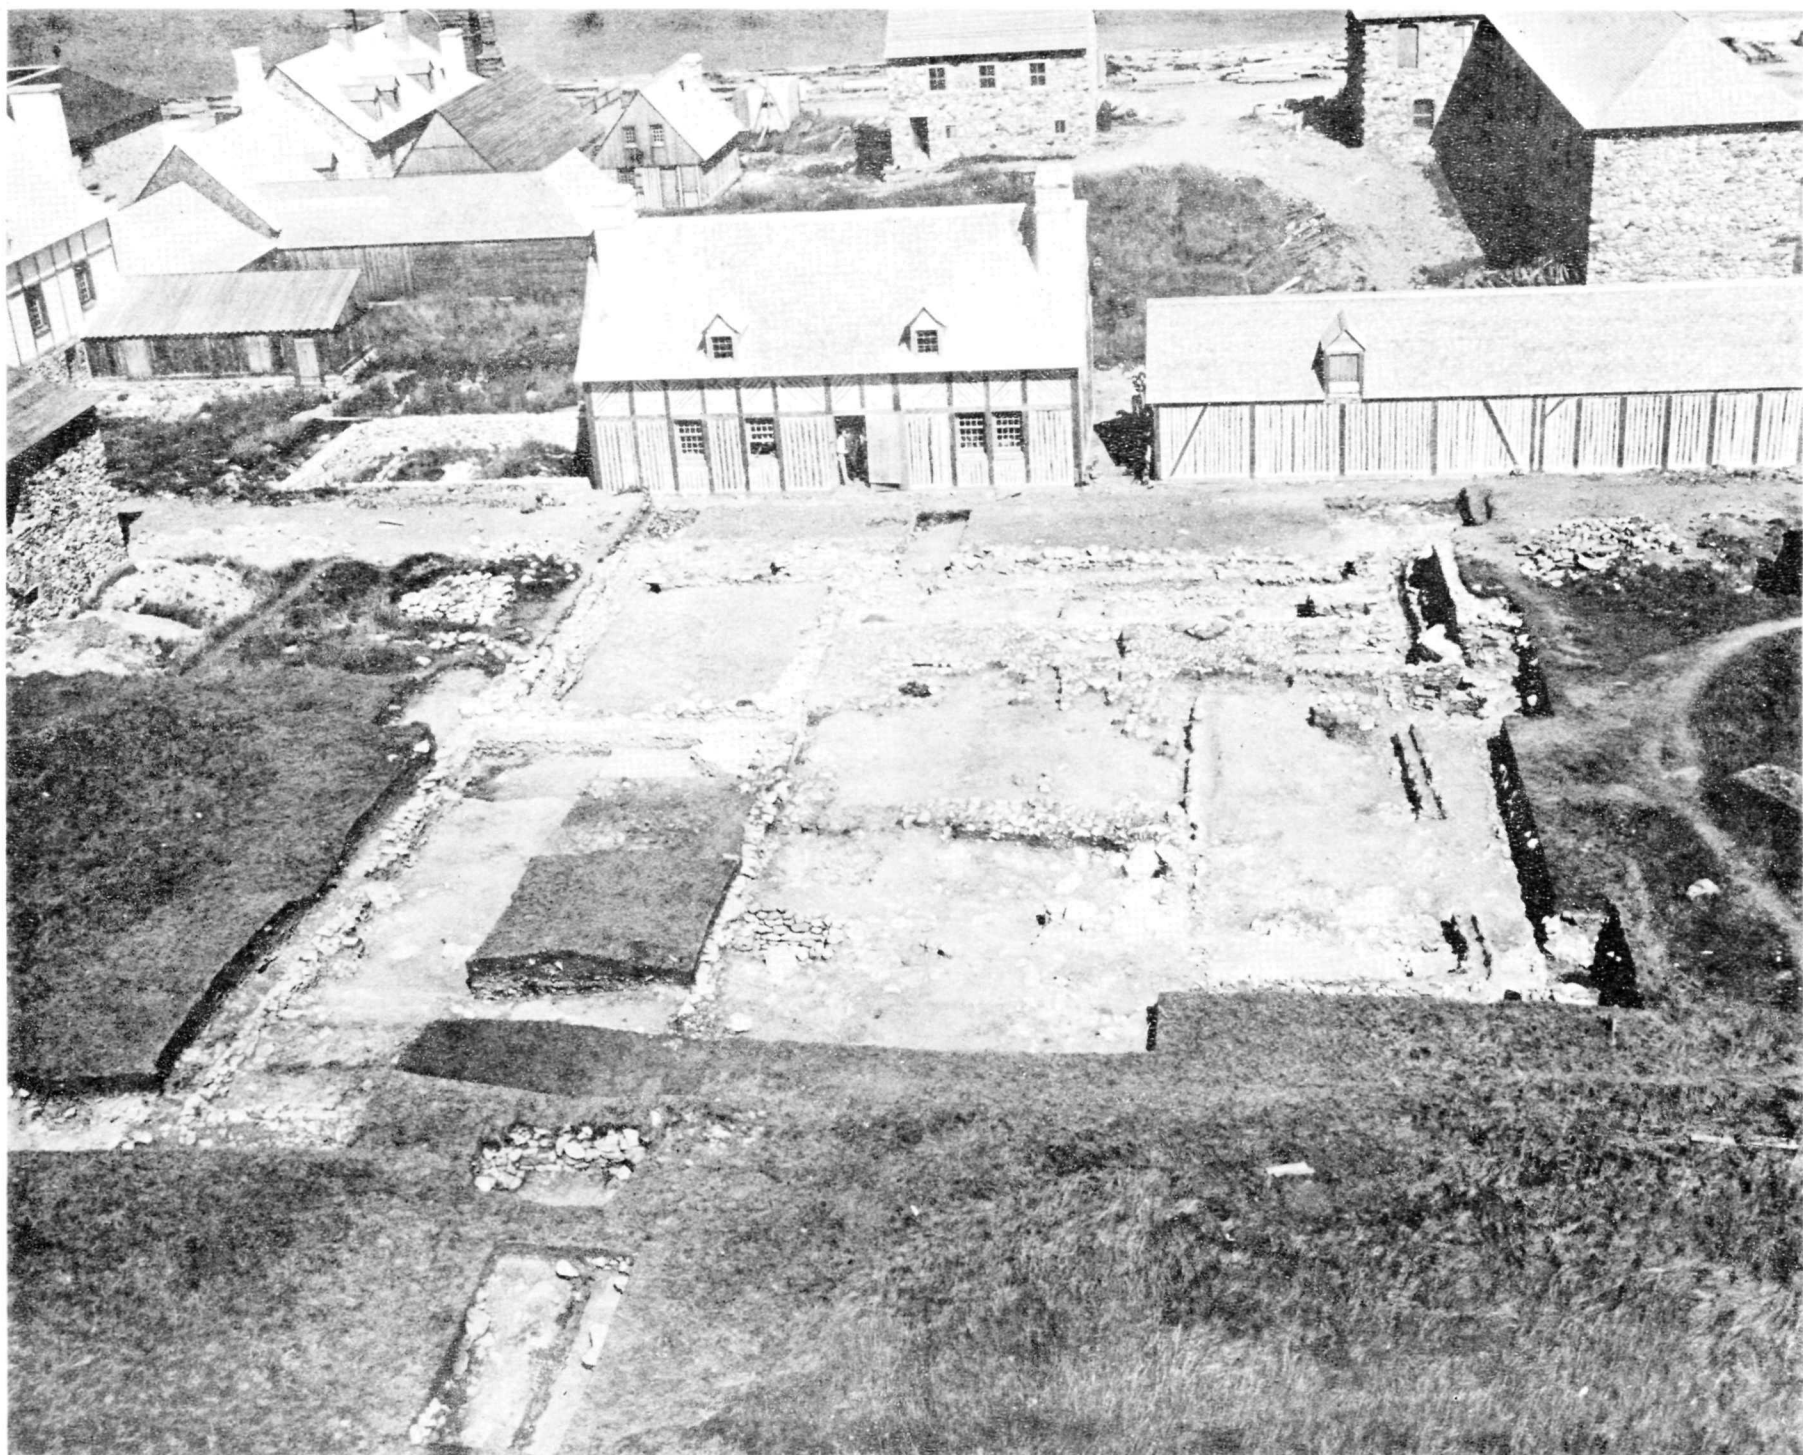
Figure 13: Aerial photograph showing structural remains of de Pensens-de la Vallière storehouse and Loppinot-Dangeac house. Partially excavated New England craftsmen's shop can be seen in foreground. Direction: north.

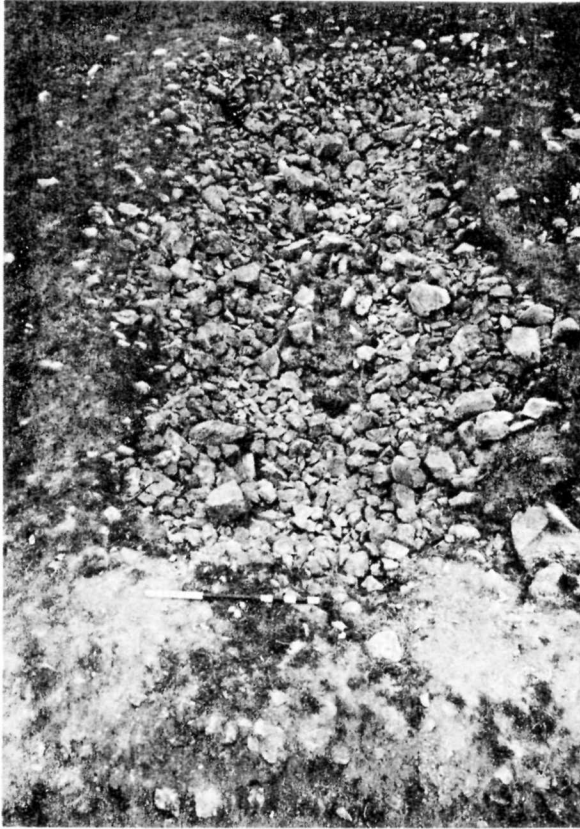
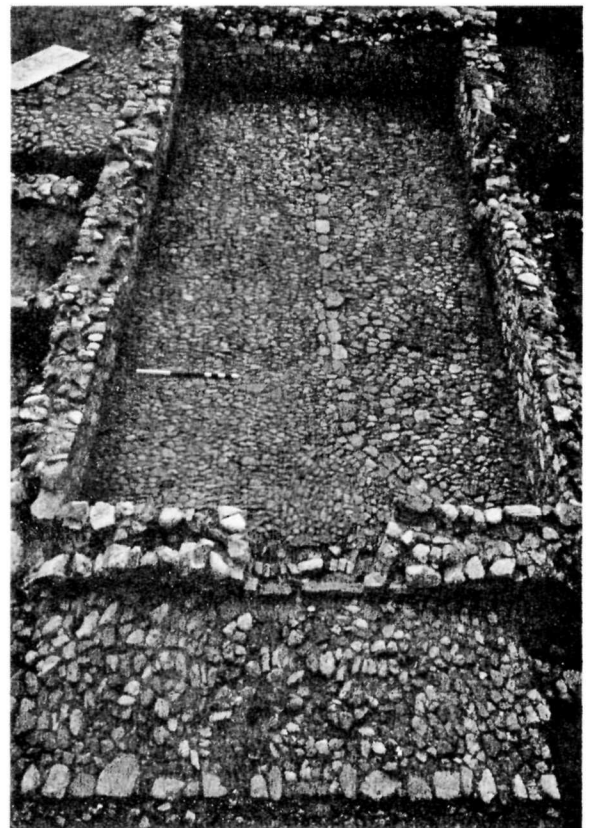
Figure 16: Top: de Pensens-de la Vallière storehouse.
 Detail of north wall and street front doorway.
 Note brick and sandstone sill and cutstone
 jam.
 Direction: south

Bottom: de Pensens-de la Vallière storehouse.
 Detail of street front doorway.

Damage and repair to the storehouse masonry shell (probably connected with one or both of the sieges) was evident both along a short segment of the west wall and at the street front doorway. The doorway repairs consisted of the replacement of some of the grey limestone step segments with coursed loose bricks and the very rudimentary insertion of a number of unmortared and uncoursed bricks at the base of the interior corner of the east doorway jamb (Figs. 11, 16). Rudimentary, unstable and ill-designed to sustain prolonged usage, this patch work repair must have occurred towards the end of the shattered existence of the storehouse or, possibly, as the presence of a mortar shell suggested, following the 1758 siege of the Fortress.

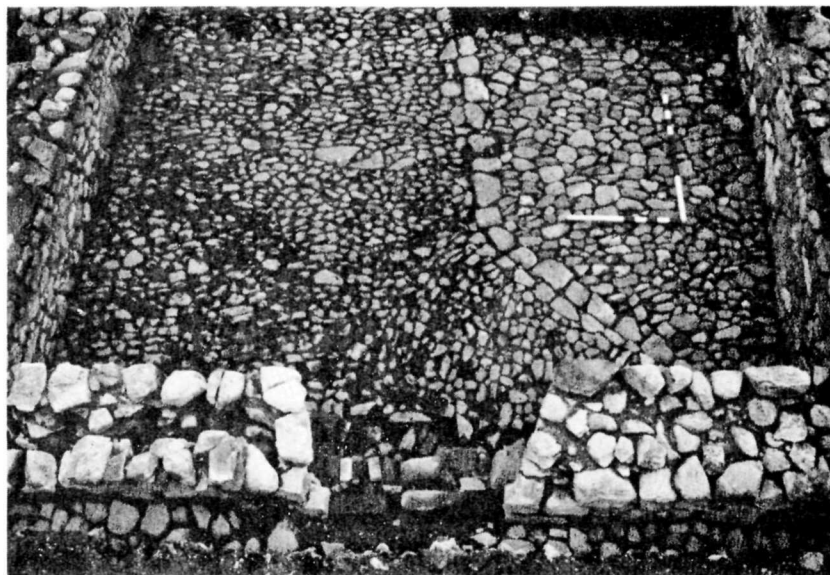
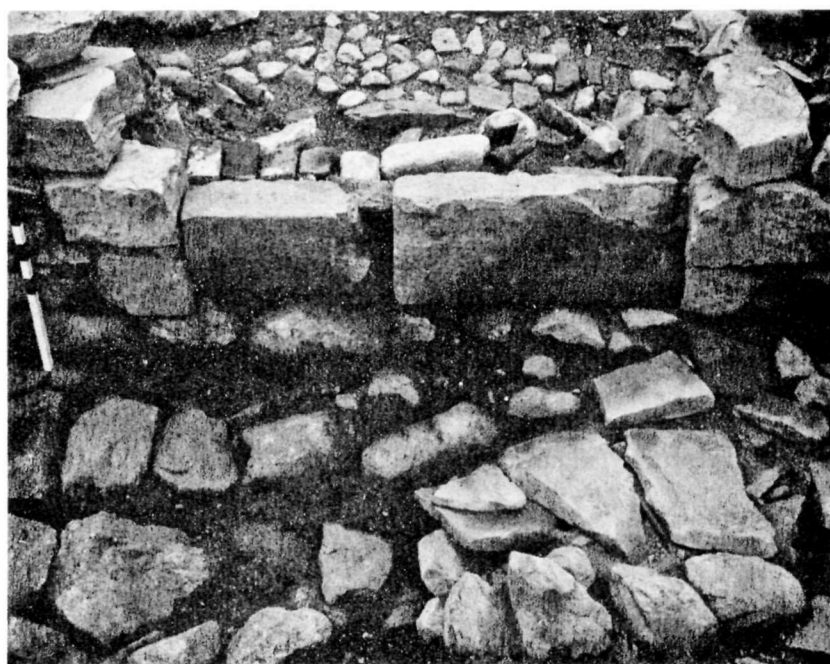
Figure 15: Top: de Pensens-de la Vallière storehouse.
Detail of interior masonry wall construction.
Direction: west.

Bottom: de Pensens-de la Vallière storehouse.
Detail of exterior wall construction. Note
that mortar is leached out.
Direction: east.

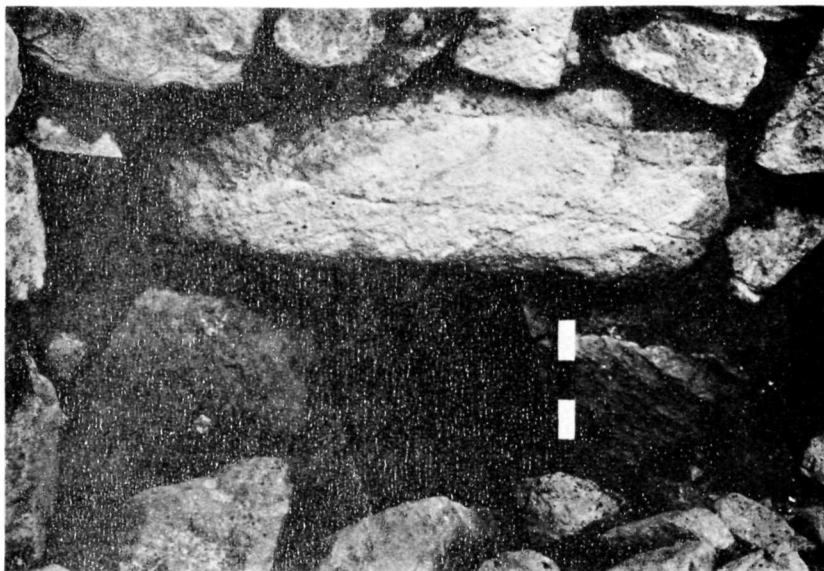
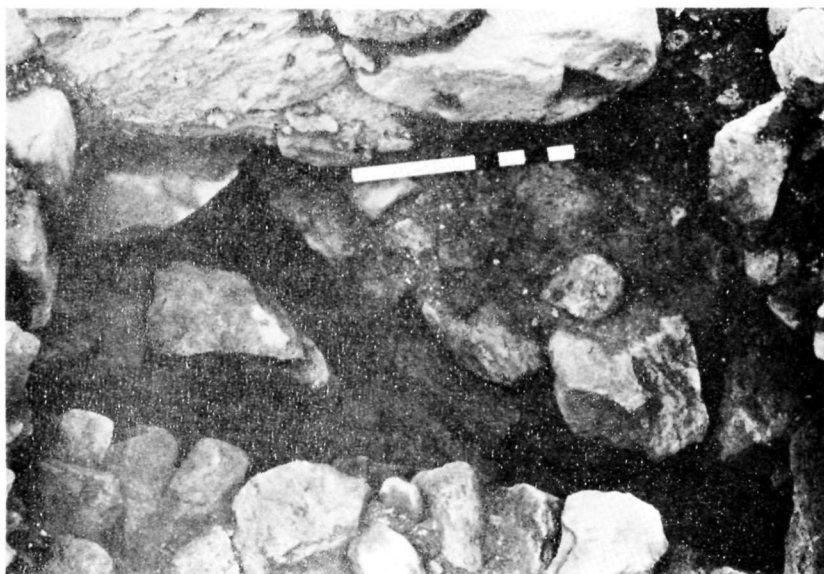
Figure 18: Top: de Pensens-de la Vallière storehouse.
Detail of possible brick repair work on
segment of west wall.
Direction: south; oblique view.

Bottom: Same as above, but viewed from
within storehouse.
Direction: west.

The identity of the scant remains of a coursed and mortared brick feature precariously perched on top of a bulging 2 m long segment of the west wall was difficult to establish (Fig. 18). These remains could have been evidence of late and hasty repair to a breached segment of wall where bricks and stones were used indifferently as repair materials or they could have been the possible re-

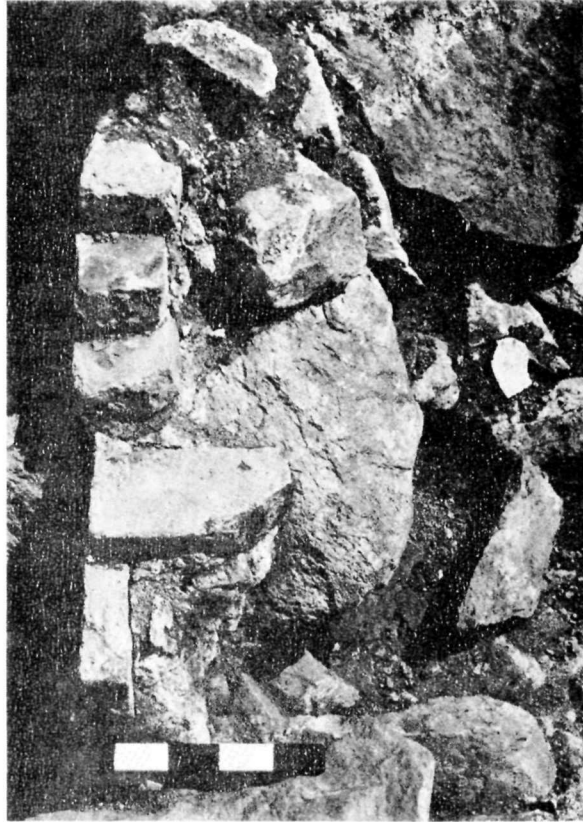
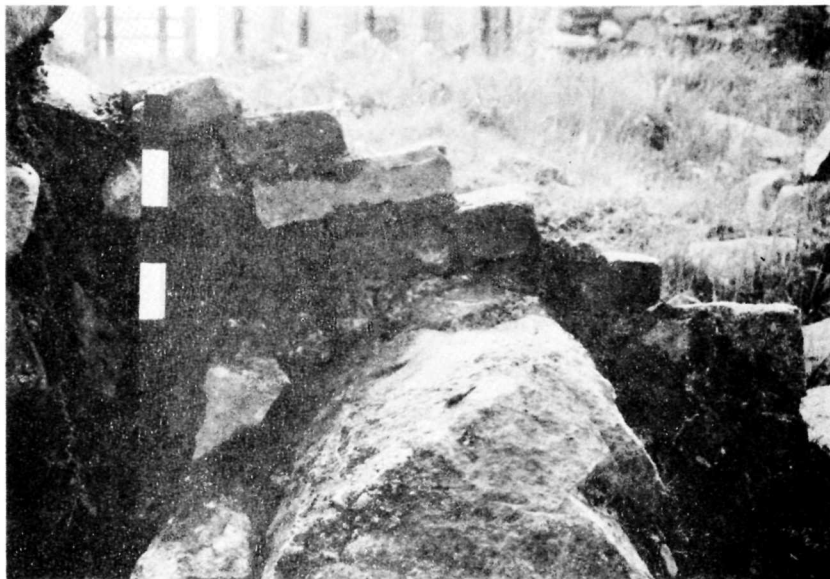
Figure 19: Top: de Pensens-de la Vallière storehouse.
Interior stratigraphy. Note slope of accumulation and relative thickness of mortar and stone debris. This occupation period layer rests immediately above pavé and below masonry collapse material.
Direction: north.

Bottom: de Pensens-de la Vallière storehouse.
Mortar and stone debris within storehouse in front of partially destroyed and bulging segment of west wall.
Direction: west.

All other layers found within the confines of the storehouse foundation walls were post-abandonment accumulations. The stone rubble and mortar layer which was thickest at the edge and thinnest at the center of the foundation remains was no doubt debris fallen or collapsed from the upper portion of the masonry walls (Fig. 19, event 16D3). It contained no noticeable wood remains, cutstones

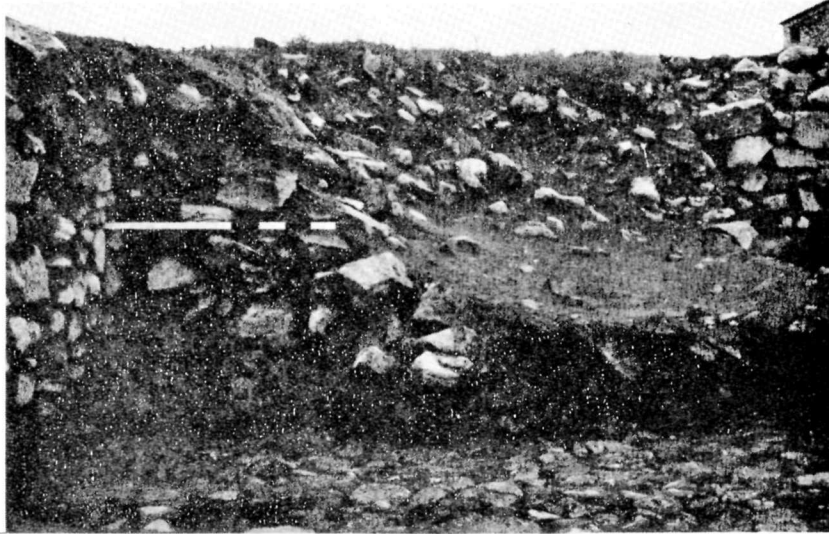
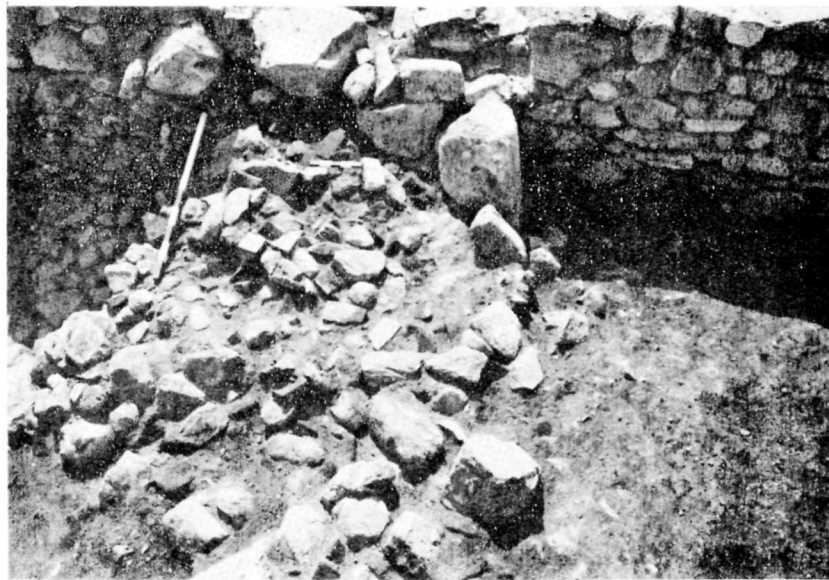
Figure 20: Top: 1746 New England craftsmen's shop.

Detail of foundation wall construction.

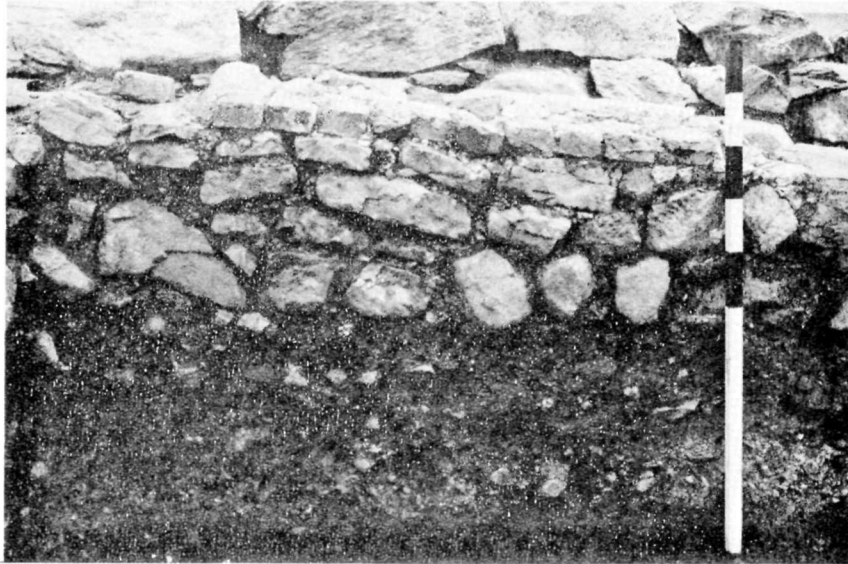
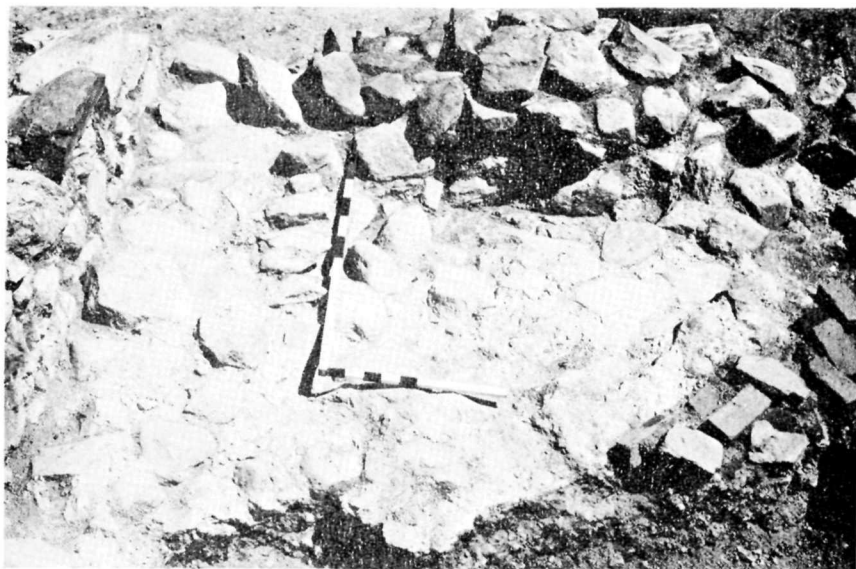
Figure 21: Top: Loppinot-Dangeac house emplacement prior to excavation. Direction: west.

Bottom: Excavated remains of Loppinot-Dangeac house. Direction: south.

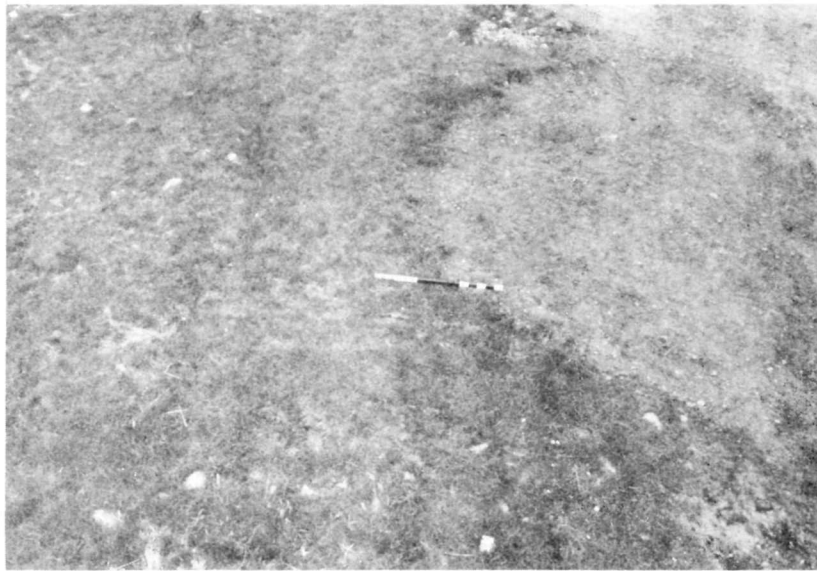
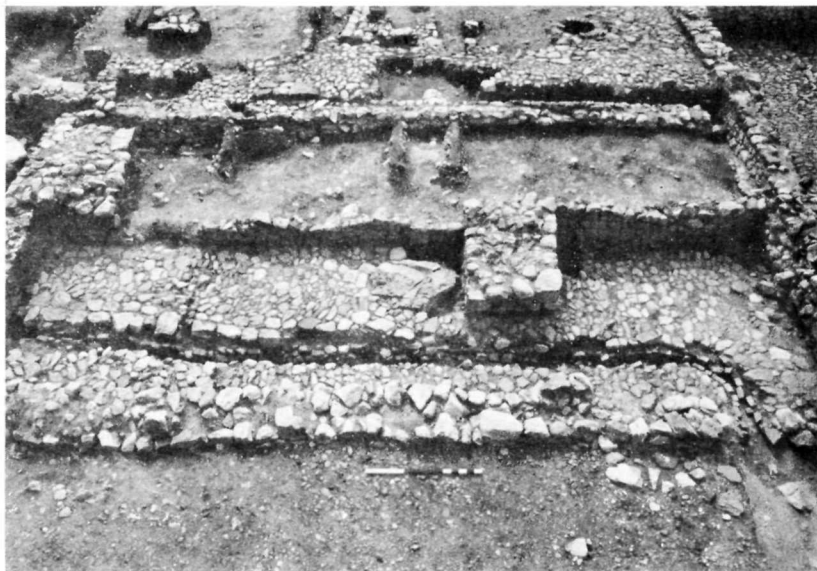
Figure 22: Top: Loppinot-Dangeac house. Segment of south wall. Note ground floor joist sill remains to the north and backyard pavé remains to the south. Direction: north.

Bottom: Detail of ground floor joist remains which extend onto south foundation wall.

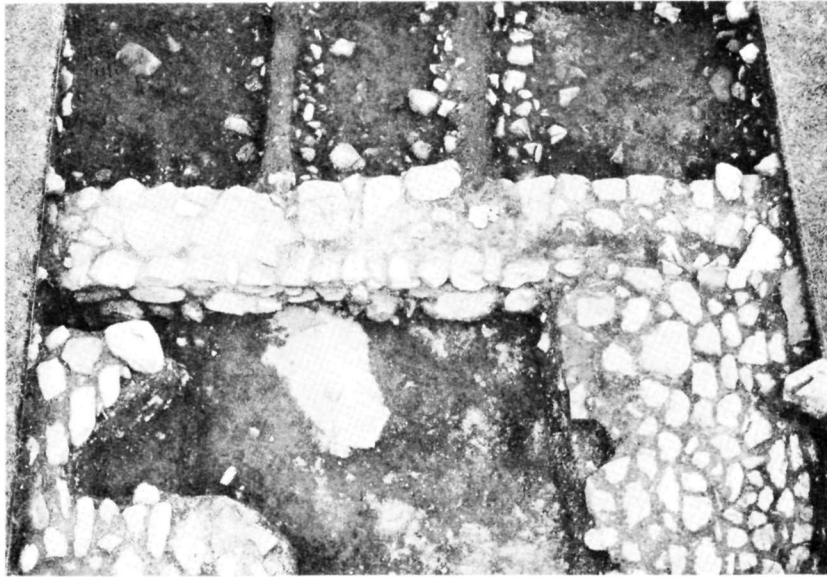
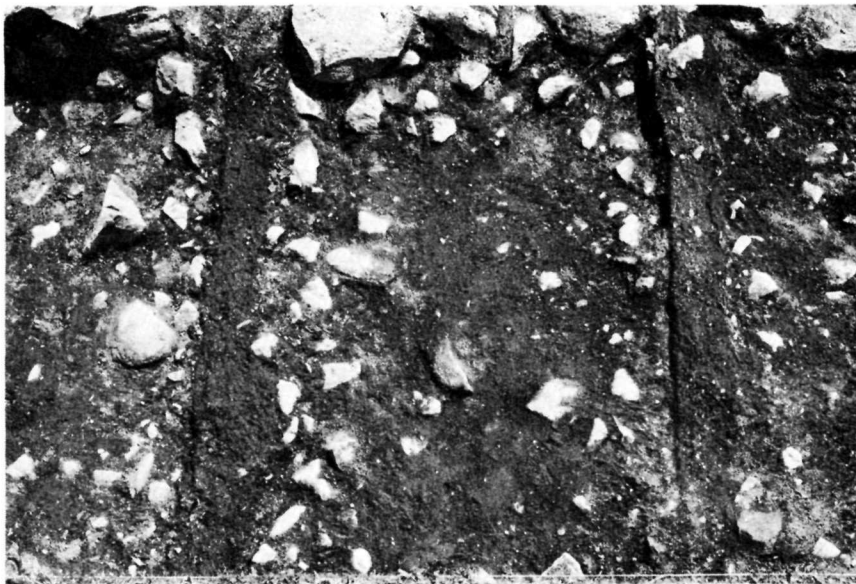
Figure 23: Top: Retaining wall running eastwest across Loppinot-Dangeac house forming south wall of basement. Note fireplace foundation on left side of photo. Direction: south.

Bottom: Detail of retaining wall construction. Note heavy mortaring of wall. Direction: south.

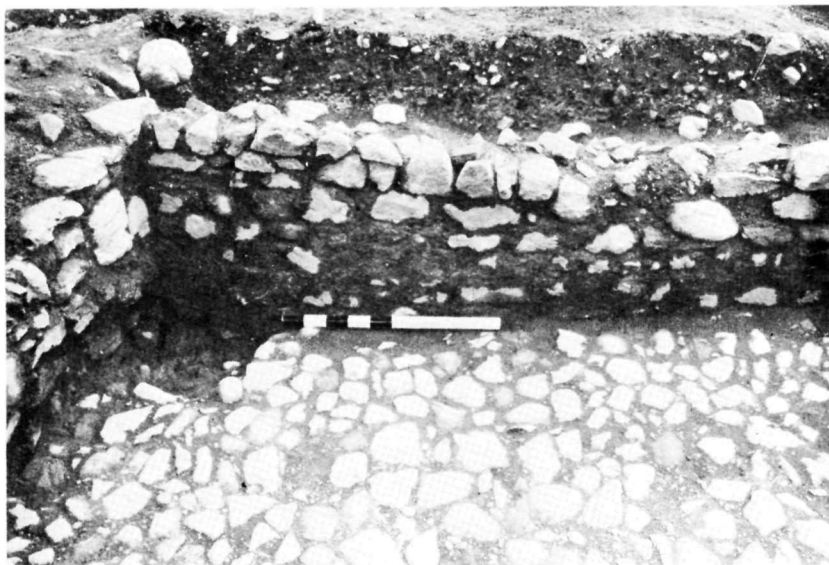
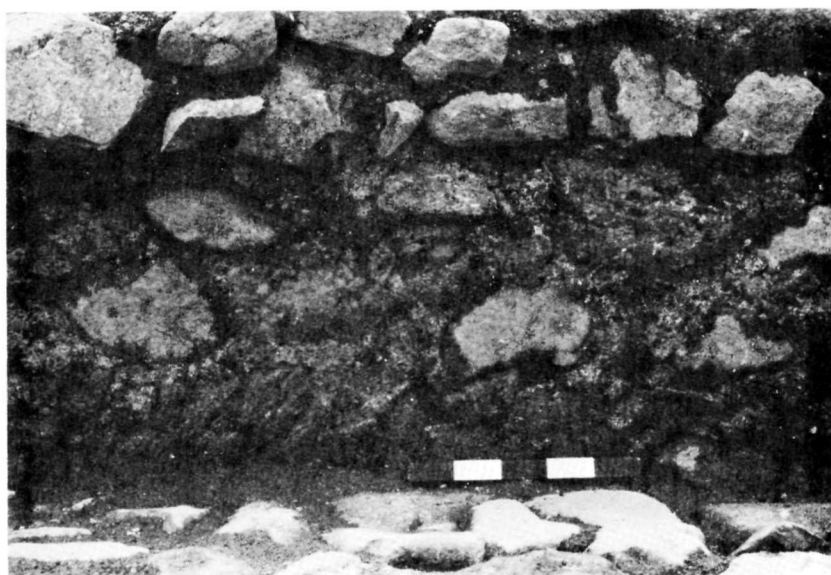
Figure 24: Top: Basement of Loppinot-Dangeac house after partial excavation. Note retaining wall with fireplace foundation extending north from it, drain with capping stones in place and the partially collapsed north wall of the house. Direction: south.

Bottom: Drain existing through doorway in north wall of Loppinot-Dangeac house. Note use of cutstone on west jamb of doorway. Direction: north.

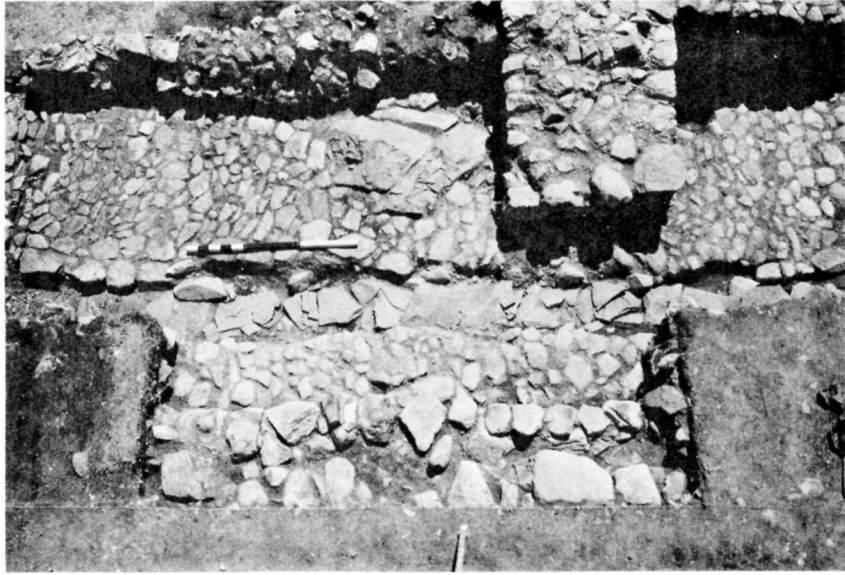
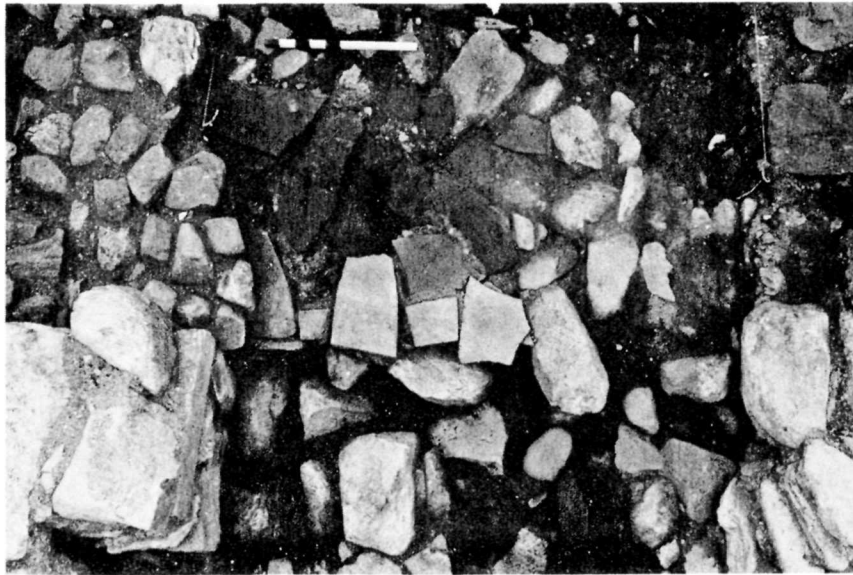
Figure 25: Top: Horizontal brace for vertical gate post
on west side of passageway between the Loppinot-
Dangeac and Fizel houses. Direction: west.

Bottom: Remains of pavé along passageway
between the Loppinot-Dangeac and Fizel houses.
Direction: west.

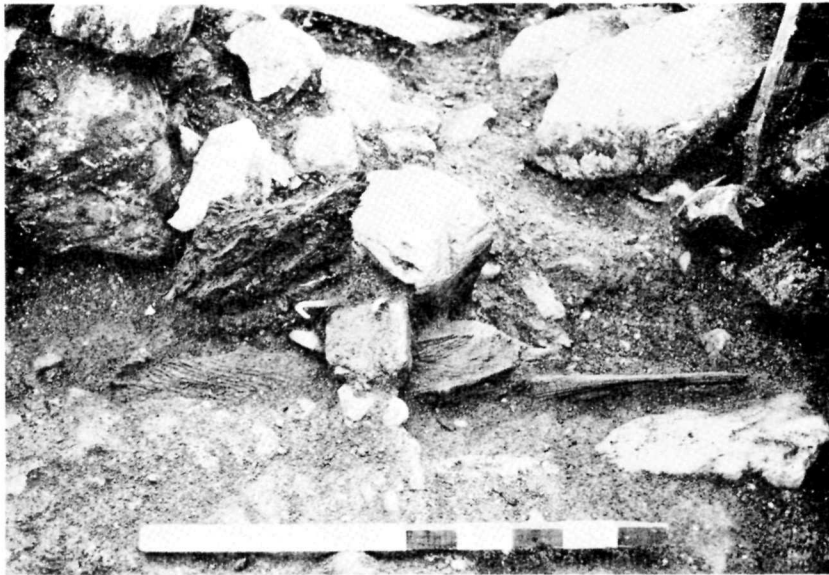
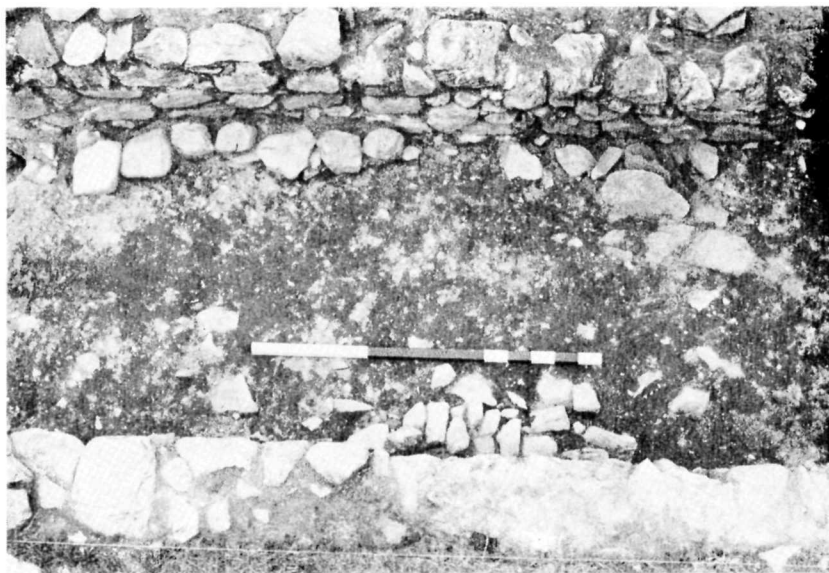
Figure 26: Top: Southeast corner of Loppinot-Dangeac backyard. Note wood lined latrine situated immediately east of Lot C fence line and L-shaped remains of drain. Direction: west.

Bottom: Detail of fence line trench along east boundary of Lot C property. Direction: south.

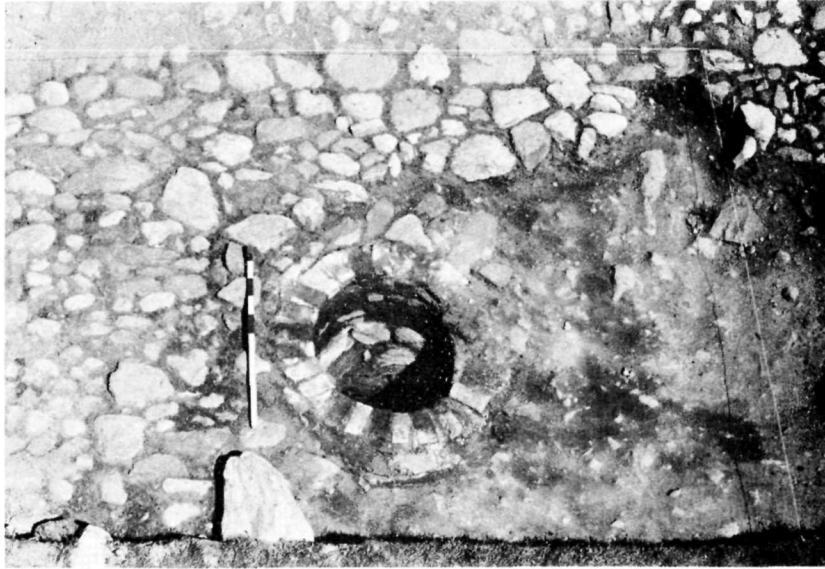
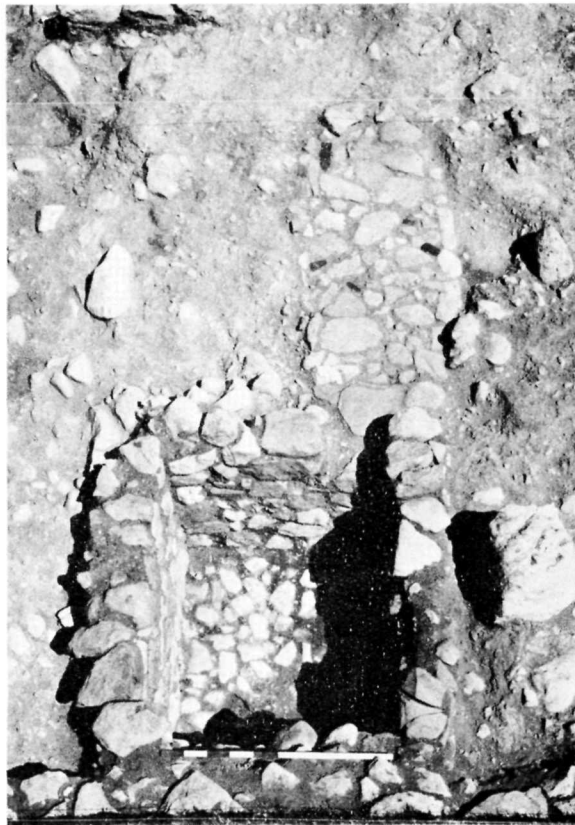
Figure 28: Top: Well and associated features along eastern boundary of the Lot C property before the removal of the covering section of the rectangular feature. Note relationship of well and drain to the rectangular feature, the Loppinot-Dangeac house to the west and the Fizel house, backyard pavé and grate to the east.

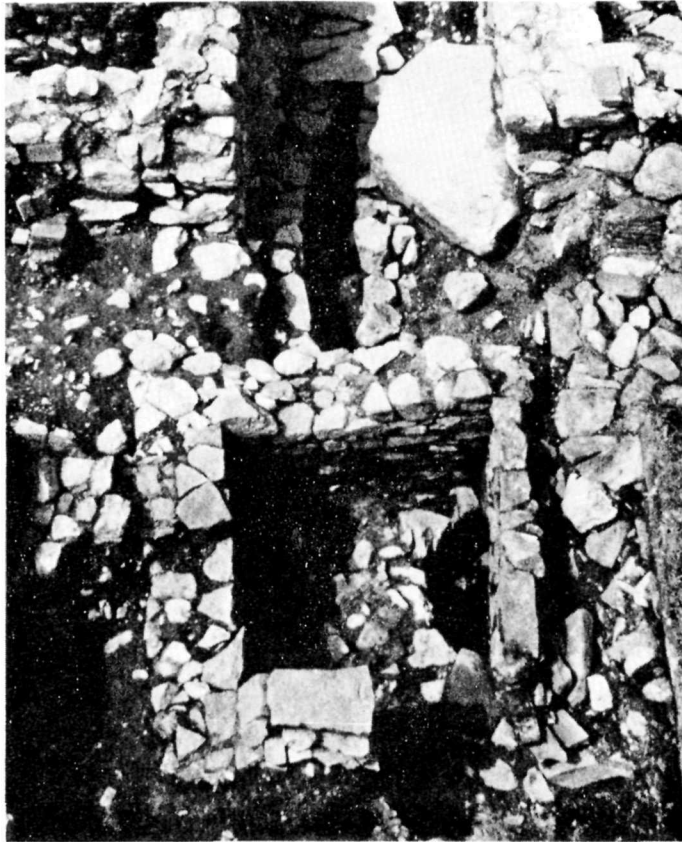
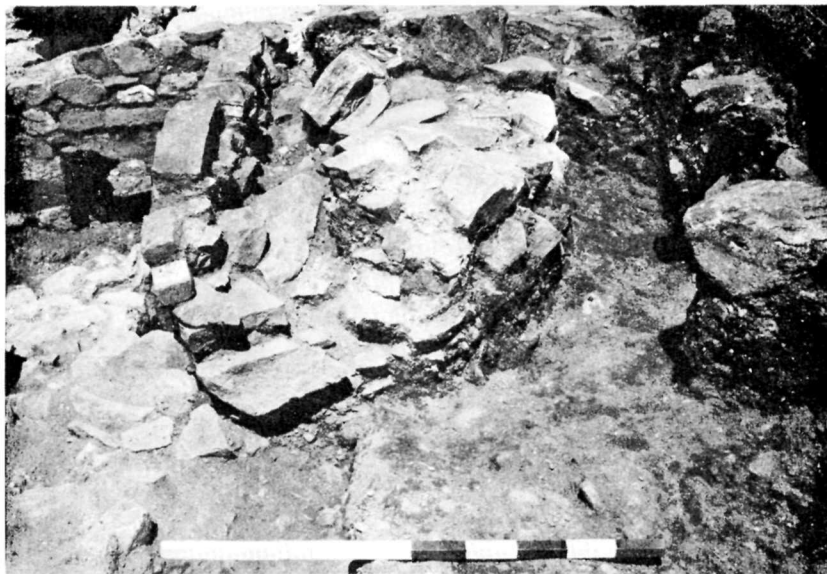
Figure 29: Top: Construction detail of the rectangular feature above the well. Note drainage outlet on north wall of feature. The edge of the well can be seen in the bottom right.

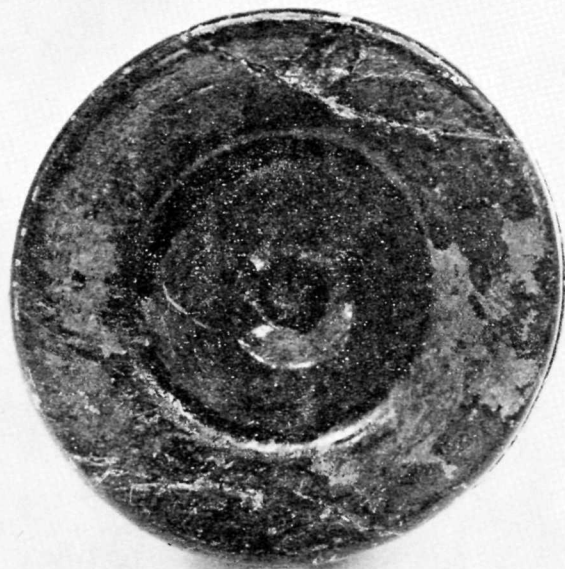
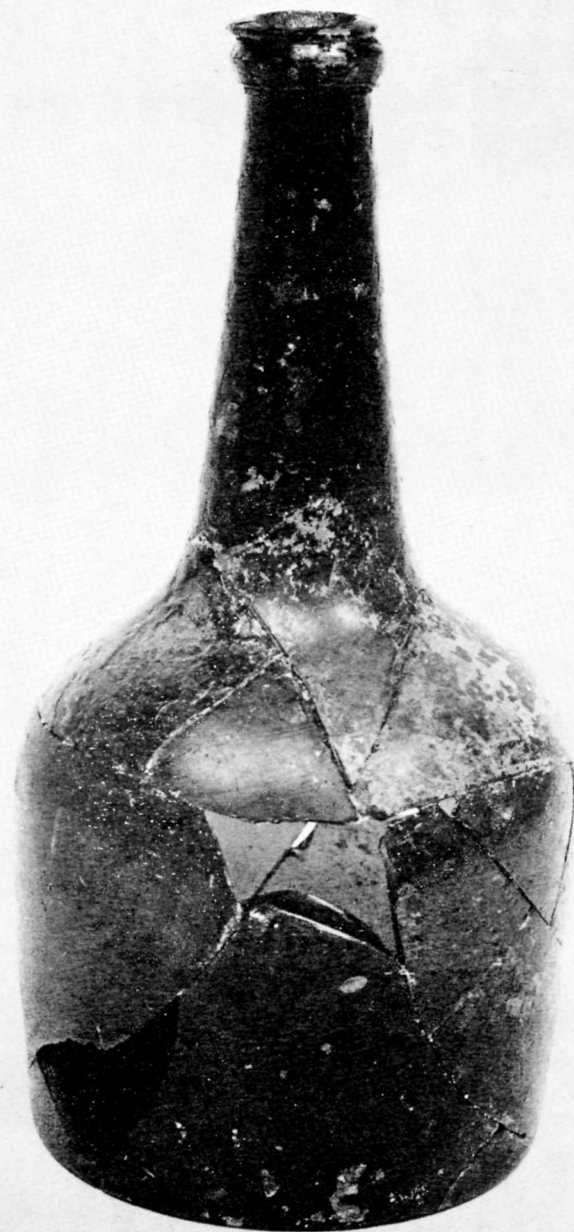
Figure 32: Two typical dark green beverage bottles. The heavily patinated example on the left (16L92N8; event 16C46) is of probable French manufacture while that on the right (16L92N19; event 16C48) is of probable English manufacture.

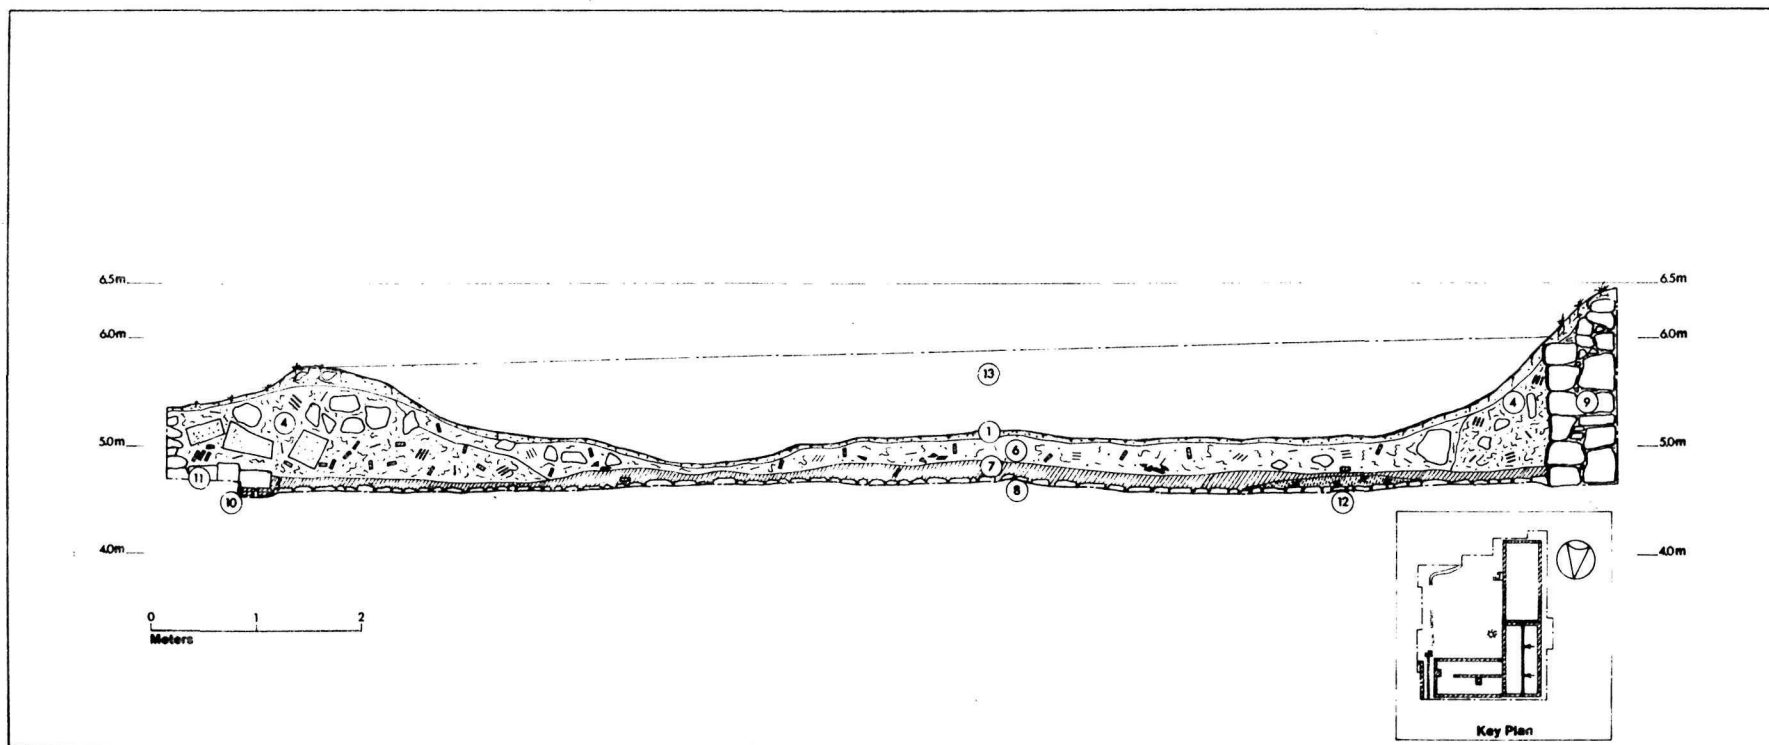
Figure 40: Eastwest cross-section through de Pensens-de la Vallière storehouse basement. North profile of 16L90B and 16L90A.

1. Sporadic sod and surface accumulation (16D1).
2. Sand lens; post occupation (16D3).
3. Sand and mortar; post occupation accumulation (16D3).
4. Mortar from collapsed masonry walls; post occupation accumulation (16D3).
5. Mortar from collapsed masonry walls but with some organic content; post occupation accumulation (event 16D3).
6. Mortar collapse with brick inclusions; post occupation accumulation (event 16D3).
7. Greasy organic material; occupation period accumulation, >1724 to >1768 (event 16D4).
8. Basement pavé floor (event 16D5) resting on rusty orange compact granular sand.
9. West and east masonry wall remains (event 16D6).
